Boiler tube corrosion caused by urea injection of SNCR system

Katri Ekholm¹, Satu Tuurna², Sanni Yli-Olli²

Abstract

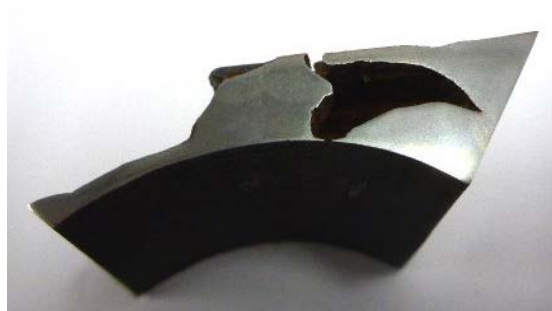
Sectioning of the corroded boiler tube showed corrosion on the fireside and at the connecting point of the boiler tube and the injection nozzle holder. After cutting down the part into smaller pieces severe corrosion was found also inside the crevice between boiler tube and injection nozzle holder. Leaking holes were found on the fireside of the tube and inside the crevice (varied in different tubes).

Figure 6. A corroded tube sectioned for microscopic examination; fireside on left, place for injection nozzle on top.

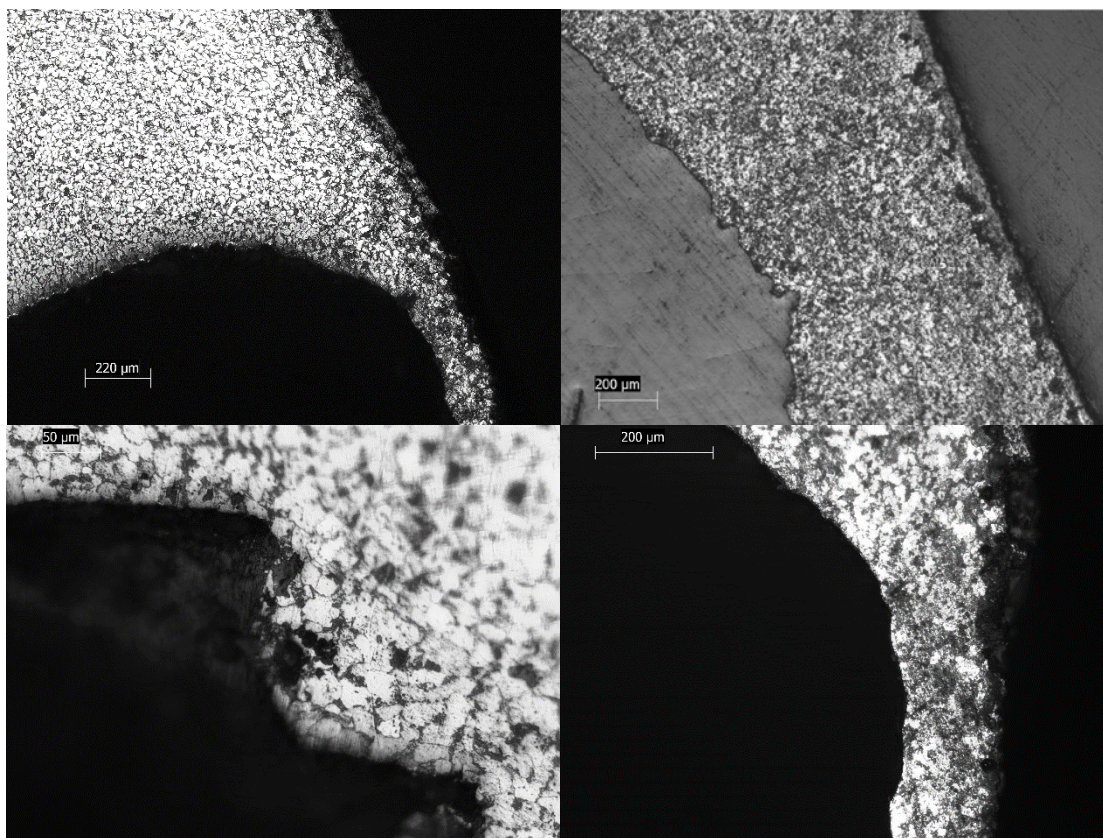
Figure 7. Fireside corrosion on the affected boiler tube.

Besides crevice corrosion, the corroded fireside area of the boiler tube showed pits and aggressive local corrosion.

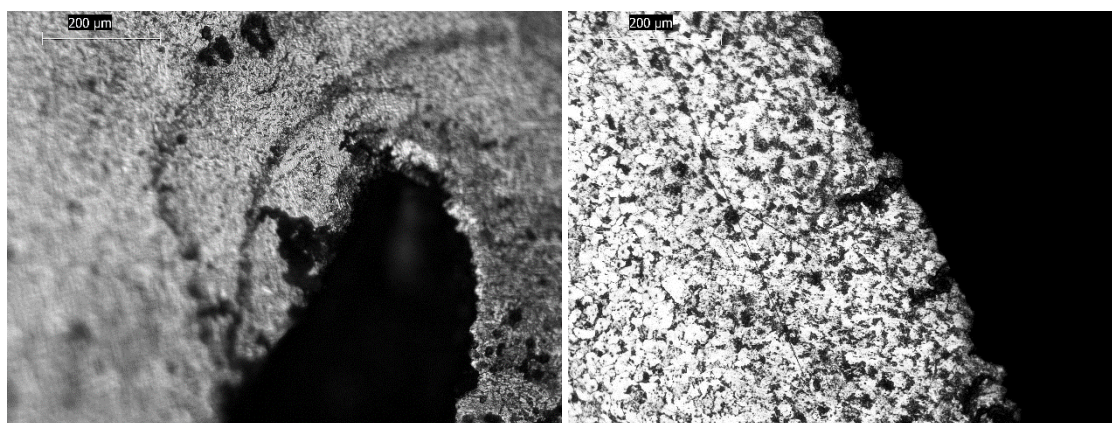
Figure 8. Corrosion in the crevice.

The microstructure of the base material was consistent with that expected of the steel grade 15Mo3. Microscopic examination showed transgranular corrosion, with corrosion pits in the crevice.

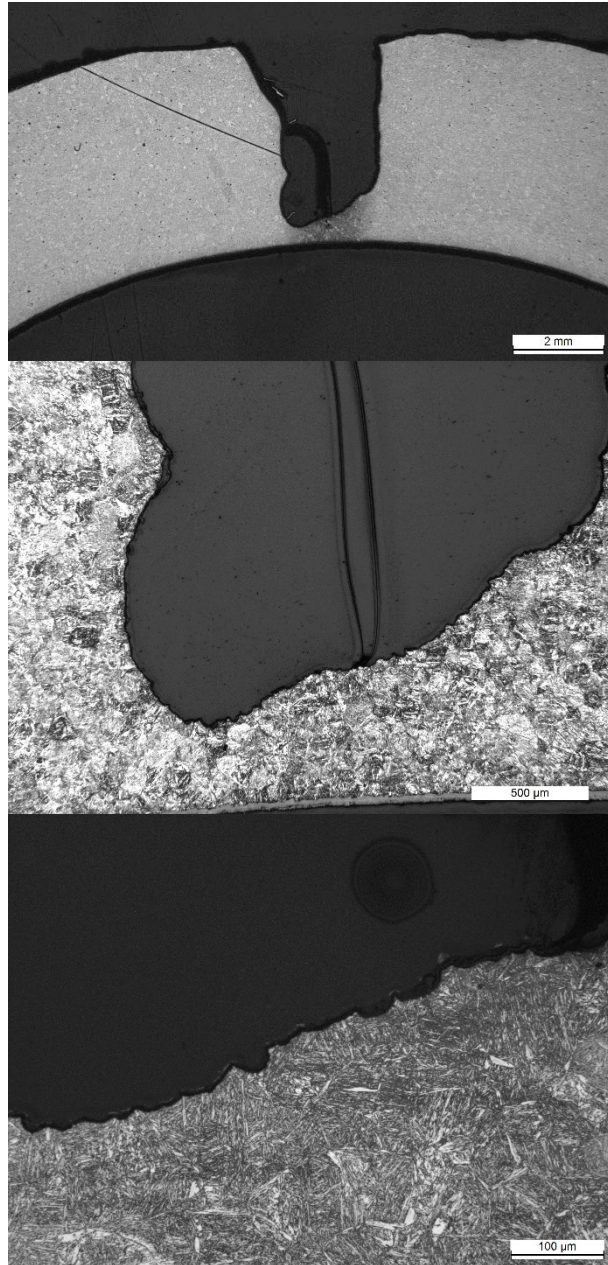
Figure 10. Cross-section of a failed superheater tube, indicating external corrosion [11].

The samples had a martensitic microstructure consistent with that expected of the steel grade X20CrMoV12-1. Microscopic analysis confirmed that the primary failure was due to aggressive external corrosion.

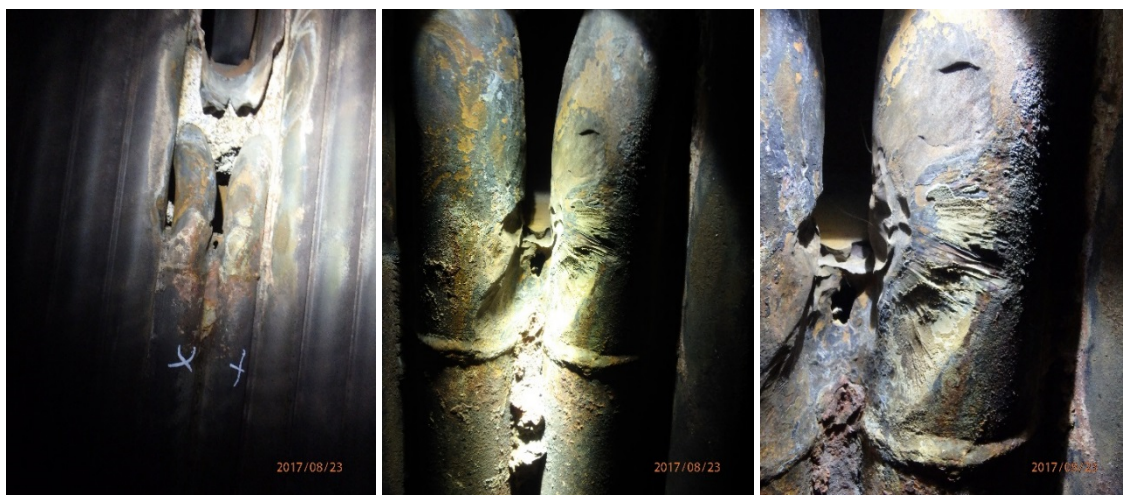
The other boiler in Hanasaari has commercial urea injection lances. In the annual maintenance in summer 2017, areas below the urea lances showed aggressive corrosion, Figure 12. Visual inspection indicated appearance that resembled the corrosion near the urea injection in the other boiler. No tube leakage was noticed before shutdown and entering the boiler. This case required no microscopic examination.

Figure 12. Corrosion below the urea injection lances.

Examination showed that some of commercial urea lances were not working properly and they were leaking large droplets.

The applied coating has protected pipes. Areas near urea nozzles are inspected in every annual maintenance. The condition of the nozzles is monitored and new experiments are made with extra care.
